Autodesk® Moldflow® Communicator 2012

Troubleshooting guide

Revision 1, 1 April 2011.

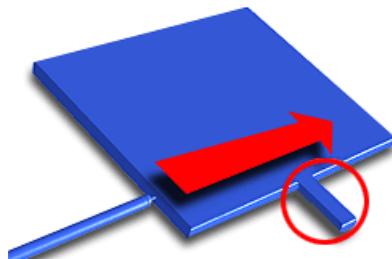
The melt cools more rapidly as it starts to slow down so the viscosity increases. In turn, this higher viscosity inhibits flow further, causing even faster cooling, so the problem is self-propagating. Hesitation can occur in ribs and in thin sections of parts that have significant changes in wall thickness. In the following diagram, the rib circled in red offers a higher resistance to flow because it is much thinner than the rest of the part.

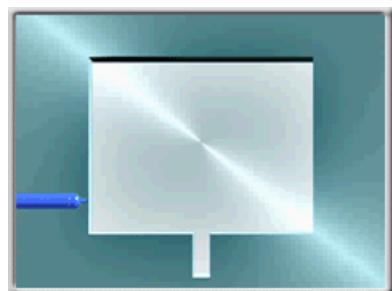
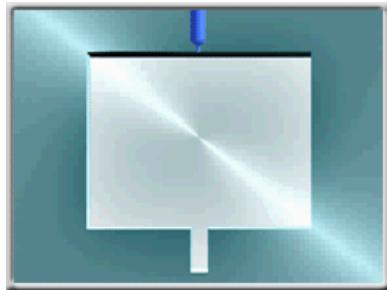
The following animations show how hesitation in a part can be avoided by using a different injection location. When there is no alternative route available, the flow in the rib will be continuous and not hesitate, as shown in the second example.

Viewing the fill time and temperature results can help explain why the hesitation occurred. The fill time plot will show hesitation by a narrow spacing of fill time contours, and the temperature plot will show hesitation by a low temperature and a large temperature gradient.

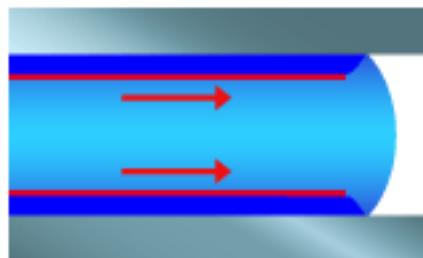
This type of stress can occur when the material viscosity is high and/or the material flow rate is high. Shear stress often manifests around the gate due to high injection speeds, and at the end of flow if a constant flow rate is used. High shear stress can cause the plastic to degrade and fail due to stress cracks. The red line in the following diagram represents the area of maximum shear stress. This is between the dark blue frozen layer and the light blue melt.

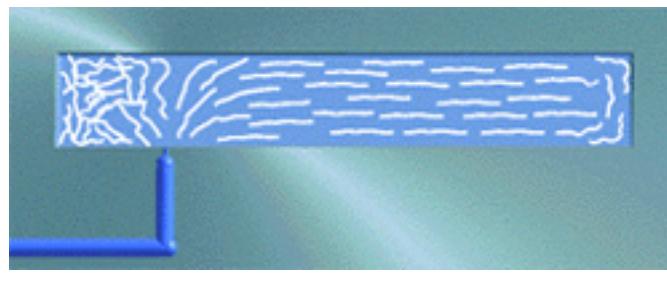
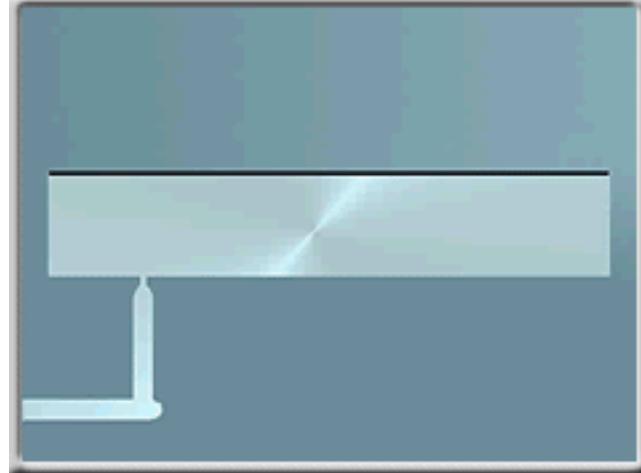
Overpacking occurs when the easiest, that is the shortest or thickest, flow paths fill first. When these flow paths have filled, they are still under pressure as extra plastic is injected into the cavity to fill the remaining flow paths. This pressure pushes more material into the already full flow path, causing it to have a higher density and lower shrinkage than other regions. The overpacked fill path freezes under pressure so stresses are frozen in. In the following diagram, the white lines represent the polymer molecules. Note that the flow paths are not balanced and overpacking will occur to the left side of the part.

The key result that identifies overpacking is the fill time result. Display the fill time at 100 percent fill, and look for any flow paths that do not finish at the same time as the first path. Solving overpacking requires a rebalancing of the flow paths, which can be achieved by the following:

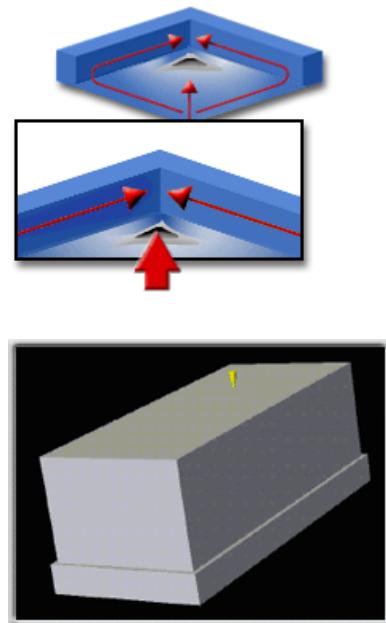
The racetrack effect indicates unbalanced flow paths and can often cause unnecessary weld lines and air traps. The following diagram shows a part with a thick rim.

The flow of plastic (red arrows) races around the rim, trapping a pocket of air (blue circle).

A large difference in wall thickness throughout a part can cause problems, but is sometimes necessary from a design point of view. However, in the previous example, the racetrack effect through the thick regions is not actually the problem. The problem is unbalanced flow that allows the

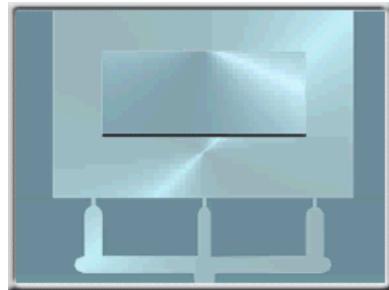
The arrow shows the direction of the underflow.

This flow reversal gives poor part quality, both from surface appearance and structural viewpoints.

Inspect the filling pattern to assess if underflow is likely to occur. Displaying the fill time result at 100% will not indicate the presence of underflow. Play the fill time animation from beginning to end and watch for any flow fronts meeting, then consider the geometry surrounding this point.

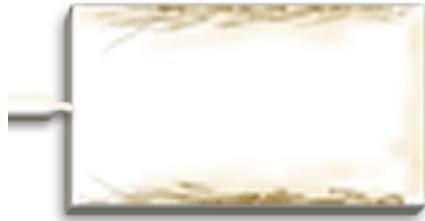
Burn marks are small, dark or black spots on the part's surface.

This phenomena is also often referred to as dark streaks or specks.

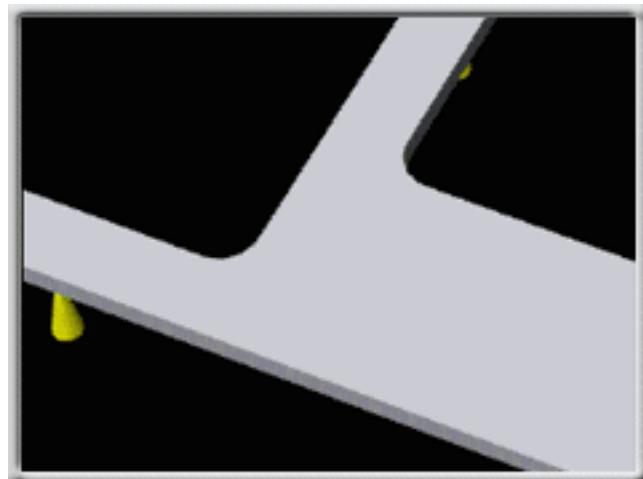
- Adiabatically heated trapped air. Air trapped in pockets may compress, heat up and cause burn marks.

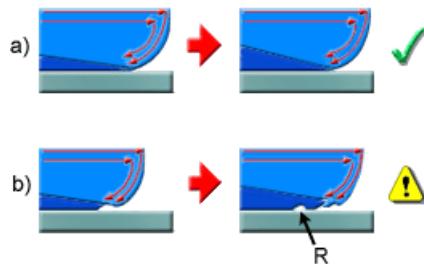
Figure 1: Ripples caused by low temperature

- Material freezing near the gate. Low melt or mold temperature, and low ram speed can result in cold material entering the cavity. This can cause the partly solidified material to take on the form of the flow pattern.
a normal fountain flow with no ripples, **b** flow causing ripples (R).

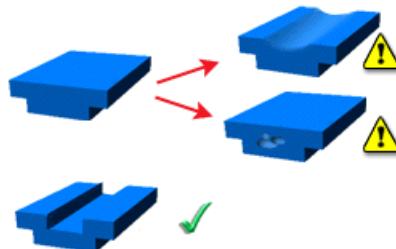
Voids are caused when the outer skin of the part is stiff enough to resist the shrinkage forces thus preventing a surface depression. Instead, the material core will shrink, creating voids inside the part.

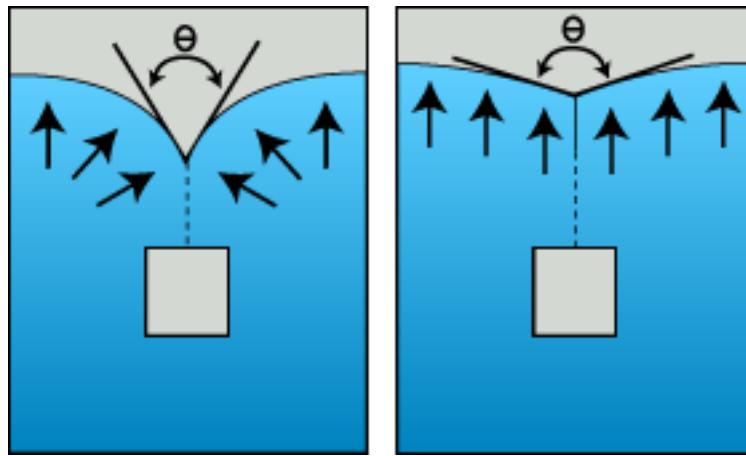
The difference between a weld and meld line is determined by the angle at which the converging flow fronts meet.

In the above diagram, the converging flow fronts (indicated by black arrows) meet. If the angle, θ is greater than 135° a meld line will form. If θ is less than 135° a weld line will form.

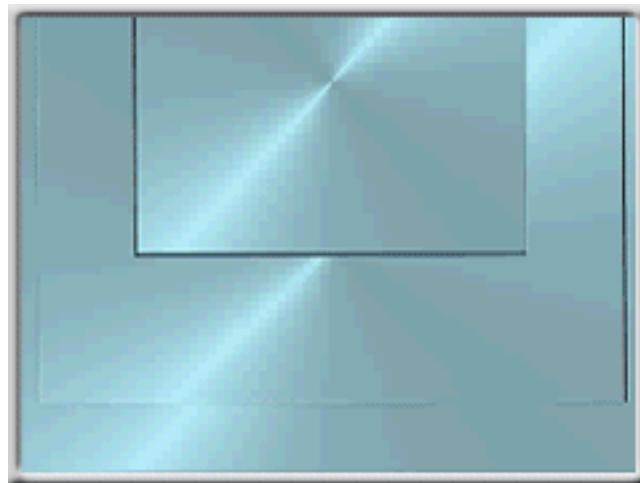
When a weld line forms, the thin frozen layers at the front of each flow path meet, melt, and then freeze again with the rest of the plastic. The orientation of the plastic at the weld is therefore perpendicular to the flow path. The following animation shows plastic filling a cavity. The weld line occurs where two flow fronts meet, and the polymer molecules are misaligned.

It is the sharp difference in molecular orientation at the weld which causes the significant decrease in strength at this point.

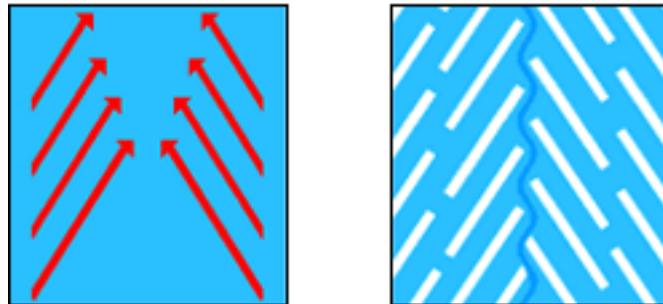
the orientation after a weld line has formed. The following diagram shows the length of a part where a meld line forms.

The red arrows show the direction of plastic flow. The white lines represent the orientation of the polymer molecules after the meld line has formed.

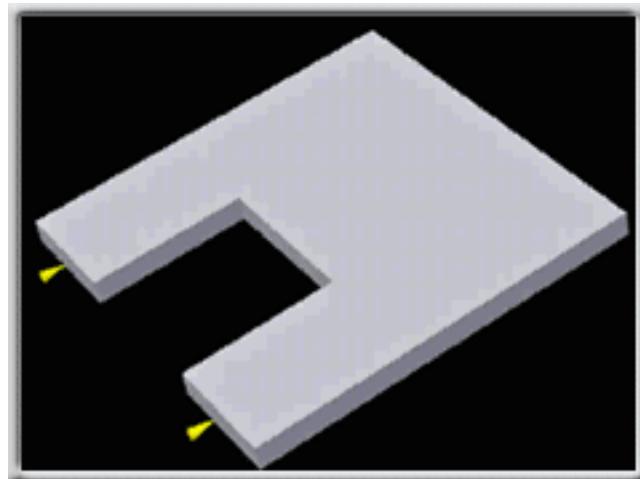
Meld lines are normally stronger than weld lines and are often much less visible.
